**CHRISTOPHER B.
BURKE
ENGINEERING, LLC**

**LAKE EDGEWOOD DAM (55-8)
2018 DAM SAFETY INSPECTION REPORT**

Morgan County, IN | May 2018

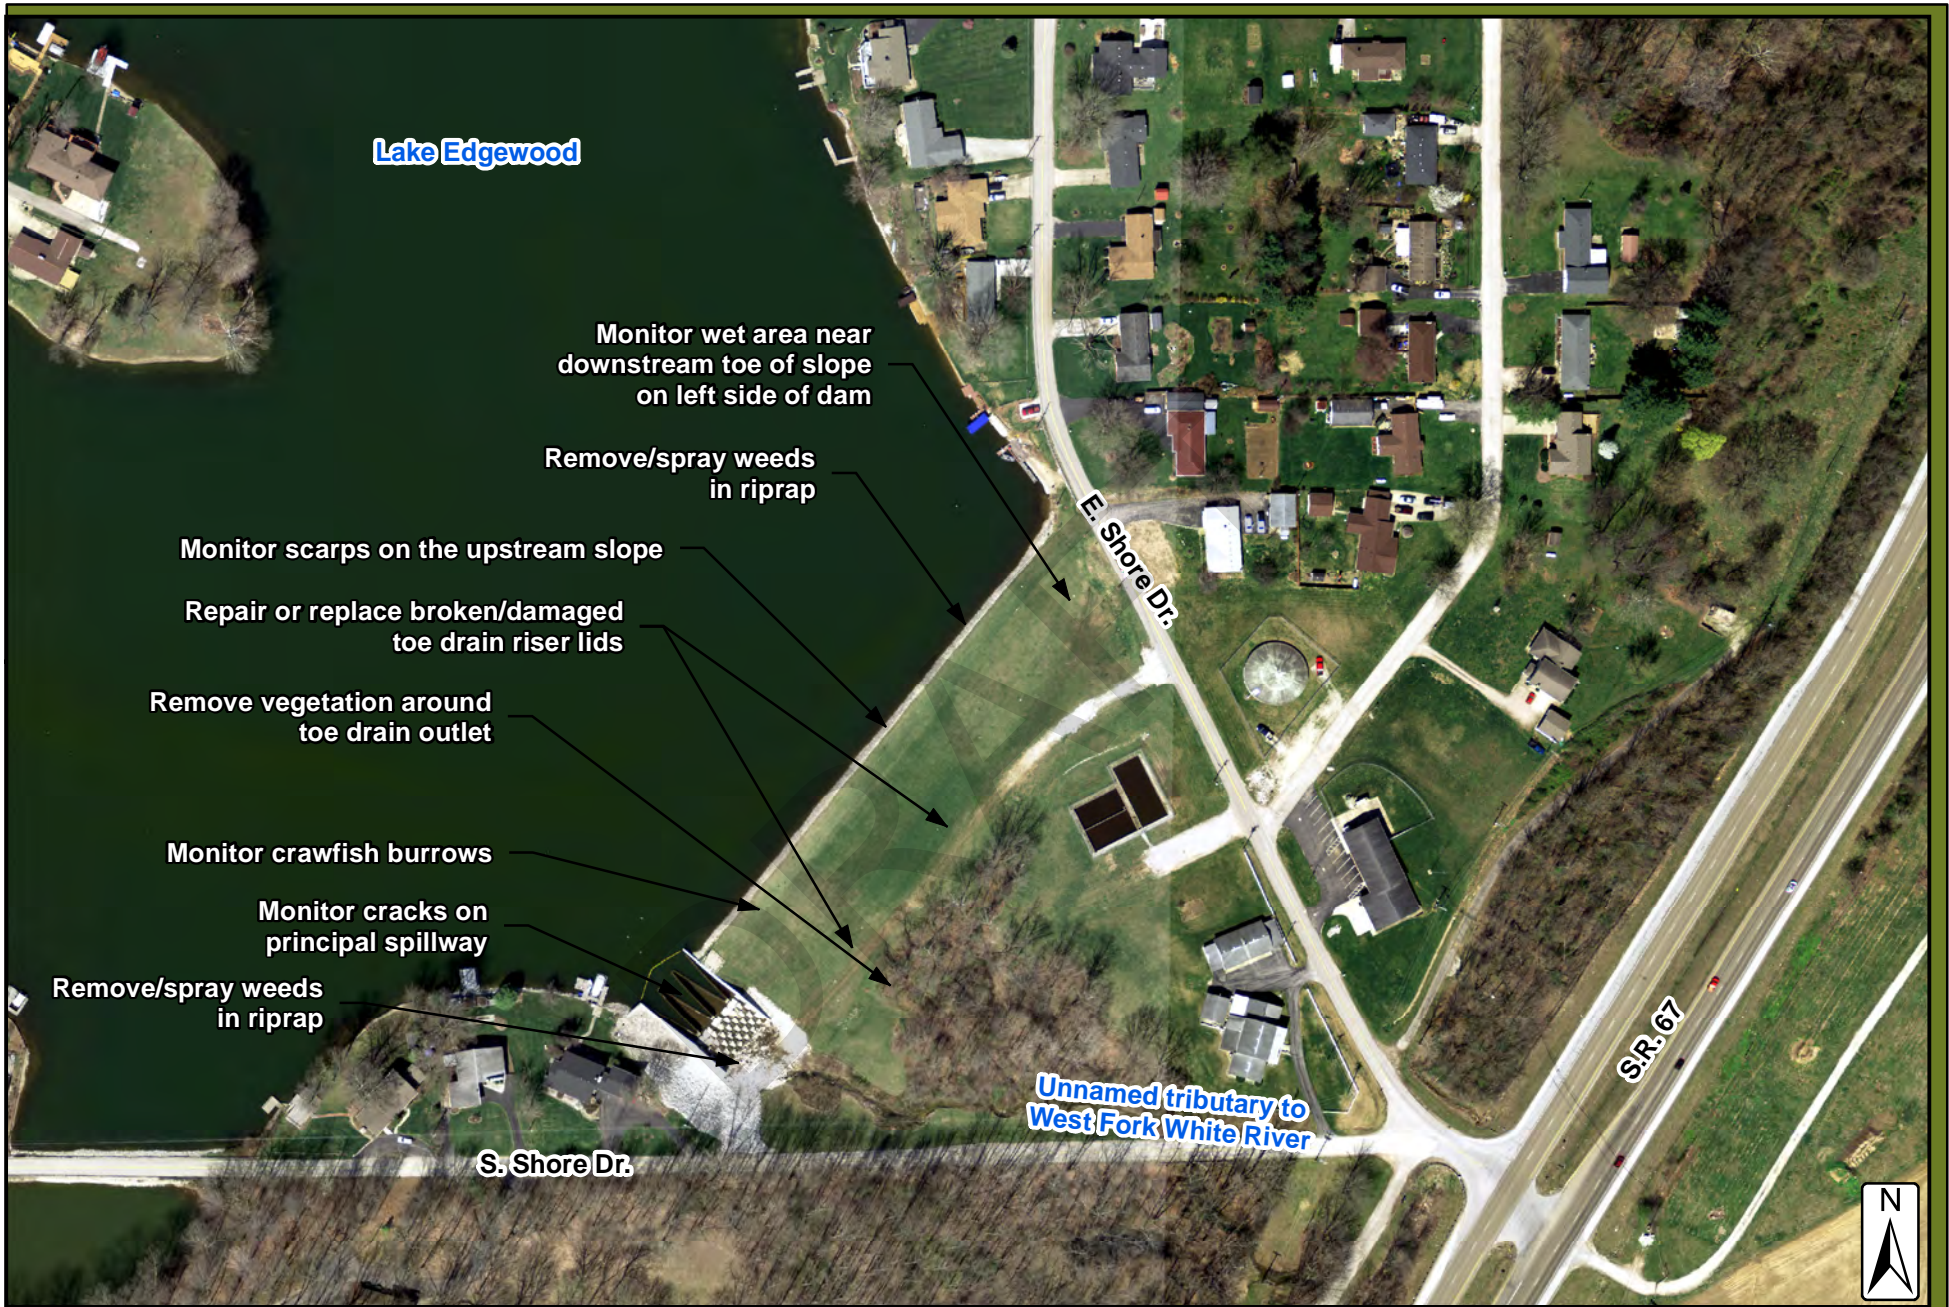
Monitor wet area near downstream toe of slope on left side of dam

Repair or replace broken/damaged toe drain riser lids

Monitor cracks on principal spillway

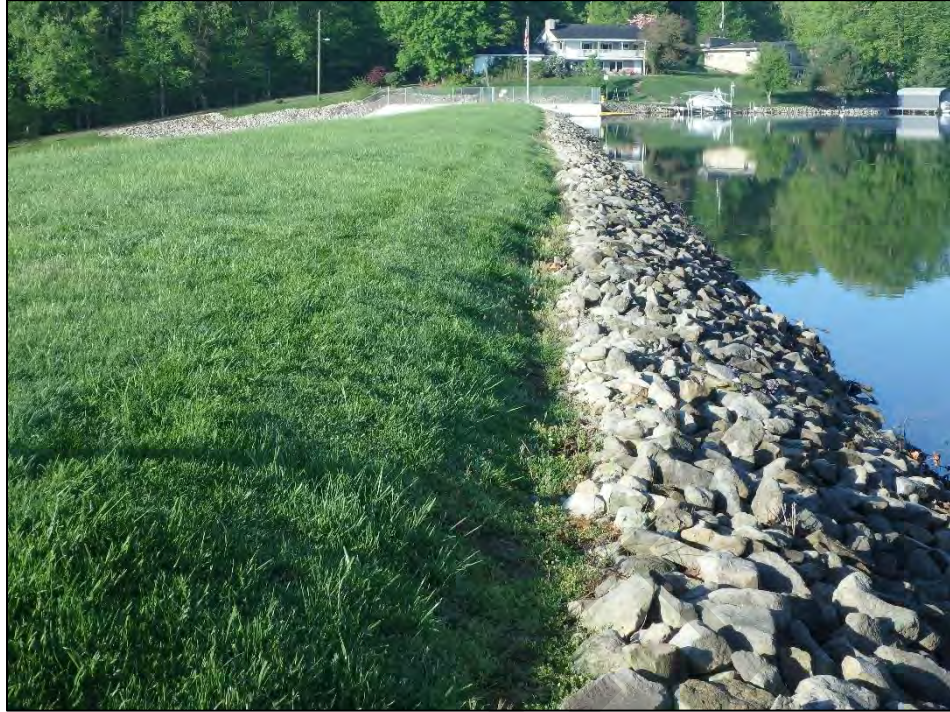
The upstream slope of the embankment is approximately 3:1 (H:V) from the crest to the shoreline and is armored with an adequate cover of riprap to about two feet above the normal pool elevation. The remainder of the upstream slope above this elevation is grass-covered. Scarping about 6 inches high was observed along the slope at the interface of the riprap and grass. Numerous crawfish burrows ranging in depth from a few inches to 4 feet and diameters of 2 inches were observed along the upstream slope. There was no visual evidence of depressions, sinkholes, cracks, slides, soil sloughs, or other deficiencies on the upstream slope. The upstream slope was considered to be in **“Good”** condition according to IDNR rating criteria.

Top:	Upstream slope from left side. Note minor scarp at the interface of riprap and grass along entire slope.
Bottom:	Upstream slope from right side.

Component	Rating	Recommendations	Schedule	Importance
Upstream Slope	Good	<ul style="list-style-type: none"> Remove or spray weeds in riprap Monitor scarping on the upstream slope Monitor crawfish burrows 	<ul style="list-style-type: none"> Immediately Ongoing Ongoing 	<ul style="list-style-type: none"> Low Low Low
Crest	Good	<ul style="list-style-type: none"> No action needed at this time 	<ul style="list-style-type: none"> N/A 	<ul style="list-style-type: none"> N/A
Downstream Slope	Good	<ul style="list-style-type: none"> No action needed at this time 	<ul style="list-style-type: none"> N/A 	<ul style="list-style-type: none"> N/A
Seepage	Acceptable	<ul style="list-style-type: none"> Clear vegetation around the toe drain outlet Monitor downstream toe of slope on the left side of the dam for potential seepage Repair or replace damaged toe drain riser lids 	<ul style="list-style-type: none"> Immediately Ongoing Within 1 yr 	<ul style="list-style-type: none"> Medium Low Low

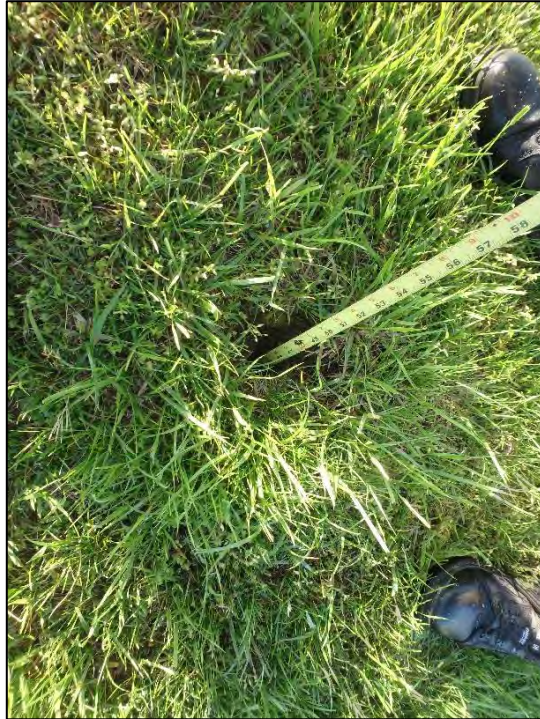
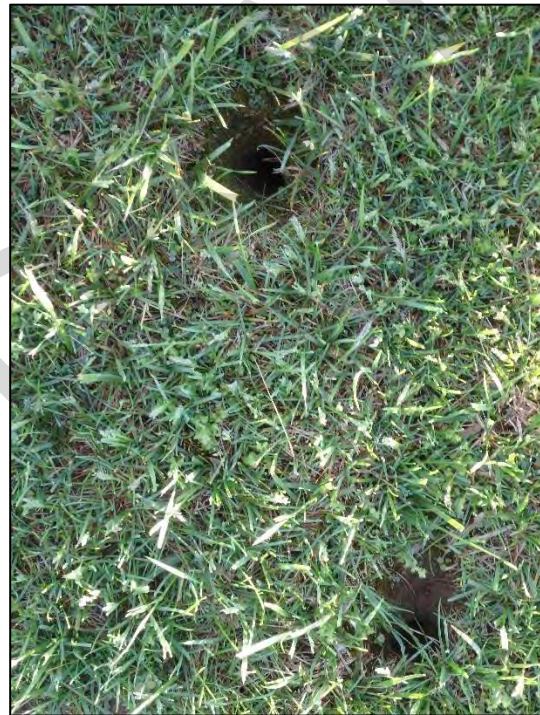
A UPSTREAM SLOPE GOOD <input checked="" type="checkbox"/> ACCEPTABLE <input type="checkbox"/> DEFICIENT <input type="checkbox"/> POOR <input type="checkbox"/>	PROBLEMS NOTED: <input type="checkbox"/> (A-1) None <input type="checkbox"/> (A-2) Riprap - Missing, Sparse, Displaced, Weathered <input checked="" type="checkbox"/> (A-3) Wave Erosion-with Scarps <input type="checkbox"/> (A-4) Cracks-with Displacement <input type="checkbox"/> (A-5) Sinkhole <input type="checkbox"/> (A-6) Appears Too Steep <input type="checkbox"/> (A-7) Depressions or Bulges <input type="checkbox"/> (A-8) Slides <input checked="" type="checkbox"/> (A-9) Animal Burrows <input type="checkbox"/> (A-10) Trees, Brush, Briars <input type="checkbox"/> (A-11) Other _____ Comments: _____ A-3: Minor scarps (height of 6 in.) along the interface of riprap and grass along most of the embankment A-9: Numerous Crawfish Burrows along slope

Top:	Upstream slope crawfish burrow. Note burrows identified along entire slope with max depth of 50 inches.
Bottom:	Upstream slope crawfish burrow. Note burrows identified along entire slope with max depth of 50 inches.

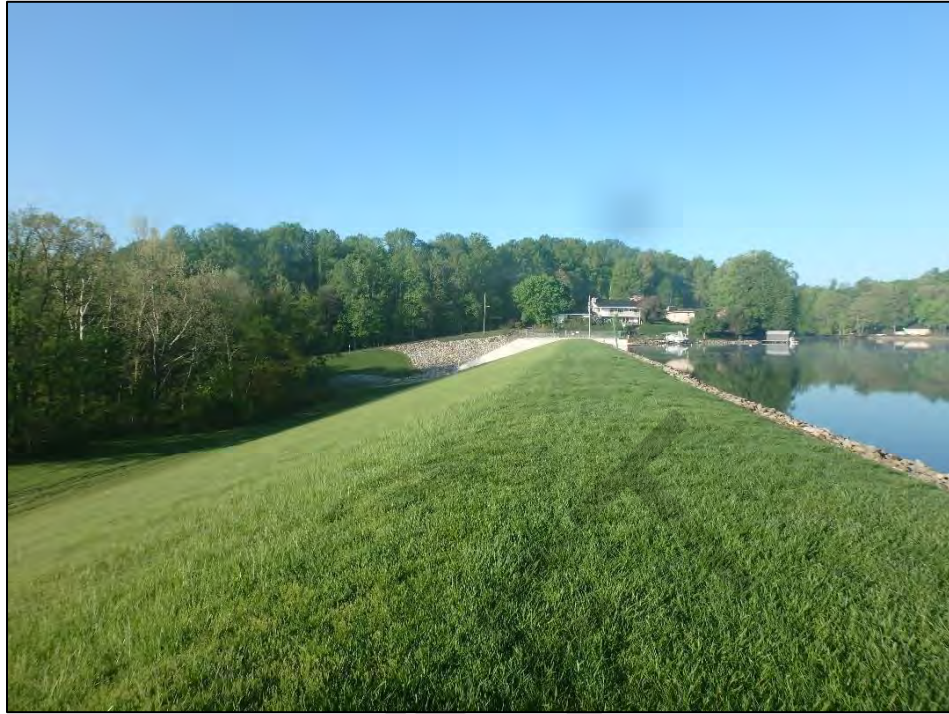
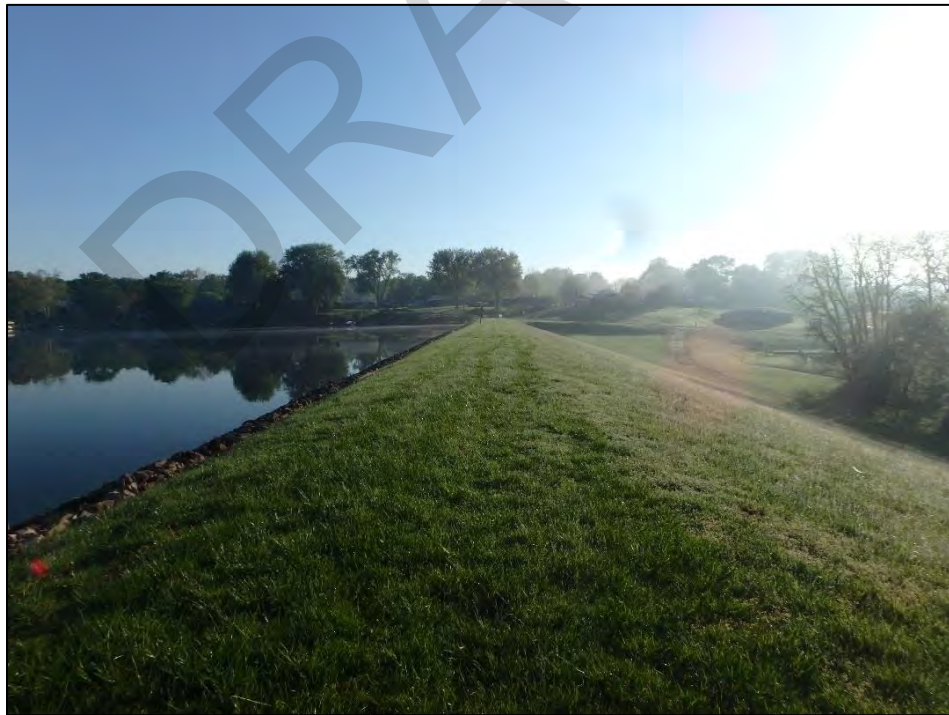
The crest of the dam has adequate grass cover and no visual evidence of vertical or horizontal alignment problems, instabilities, cracks, bulges, or other deficiencies. The crest was considered to be in **“Good”** condition according to IDNR rating criteria.

Top:	Dam crest from left side.
Bottom:	Dam crest from right side.

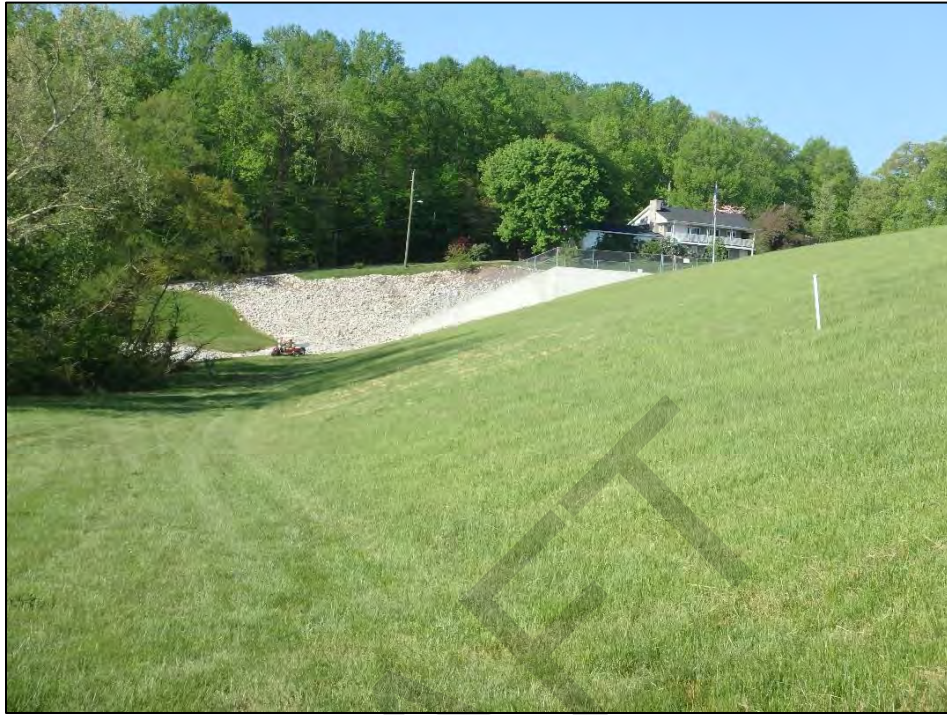
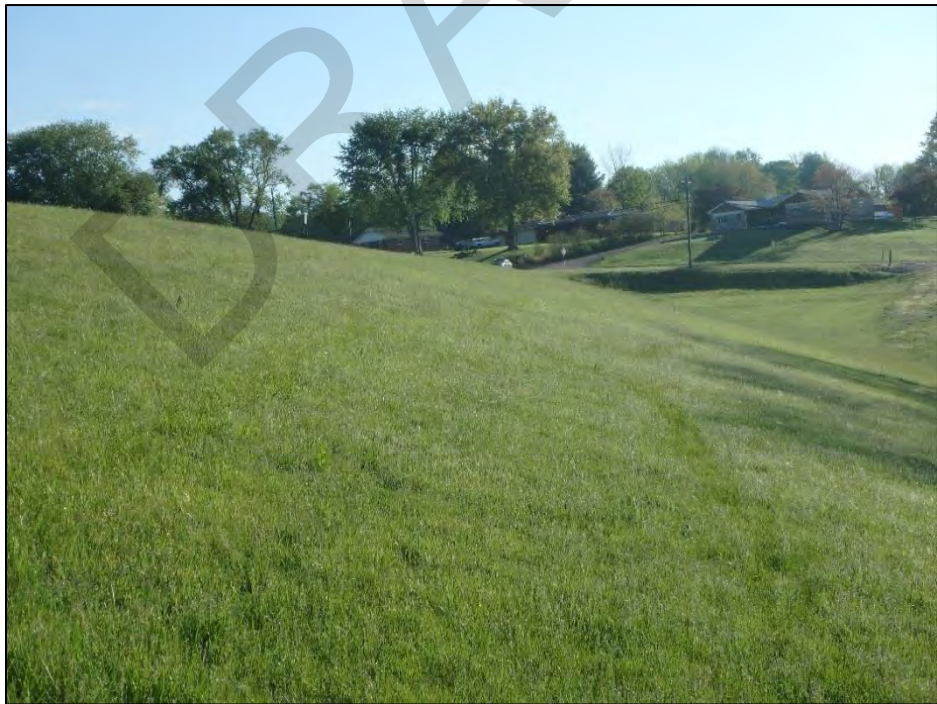
The downstream slope of the embankment is approximately 3:1 (H:V) from the crest to the toe. The slope appears to have adequate grass cover with no observed depressions, sinkholes, cracks, slides, soil sloughs, or other deficiencies found. The downstream slope was considered to be in **“Good”** condition according to IDNR rating criteria.

Top:	Downstream slope from left side. Note uniform slope and adequate grass growth.
Bottom:	Downstream slope from right side. Note uniform slope and adequate grass growth.

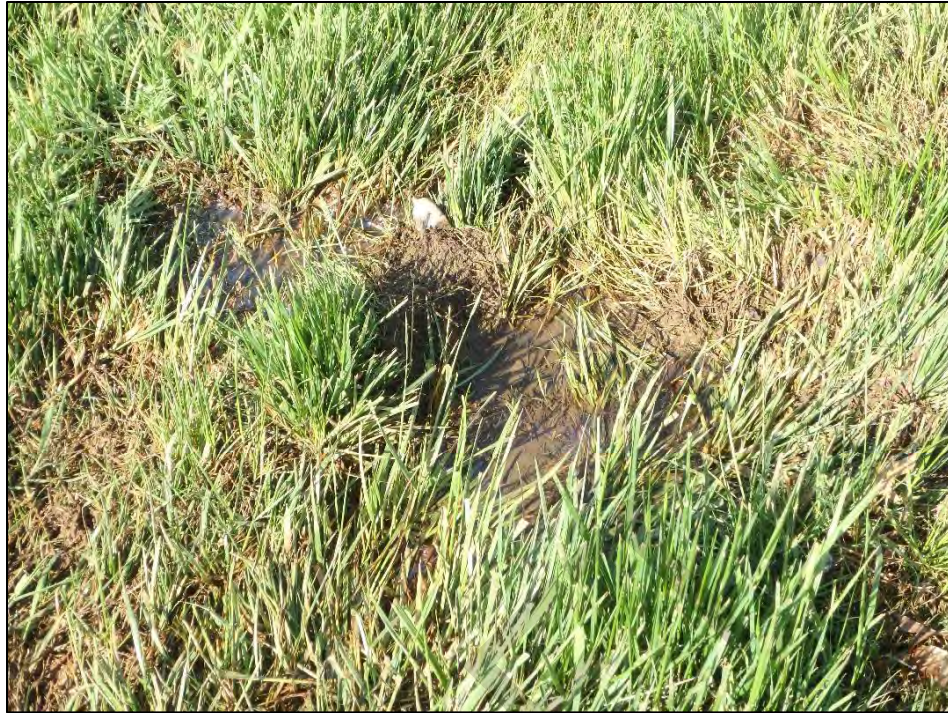
A wet area was observed near the downstream toe of slope on the left side of dam from the abutment to the near west end of the gravel drive from East Shore Drive (a distance of approximately 200 feet). The wet area was approximately 20 feet in width and 30 feet in length near the left abutment. This area has been observed to be wet in the past, even prior to the dam rehabilitation. The wetness appears to be due to surface runoff from the dam and left abutment. No vegetative growth that would suggest the persistence of wet conditions was identified, and no oily sheen

that would suggest seepage was observed. No discharge was observed in the toe drain cleanouts.

Top:	Downstream slope near left abutment. Note wet area which appears to be the result of surface runoff.
Bottom:	Downstream slope near middle of embankment. Note damaged toe drain cleanout cover.

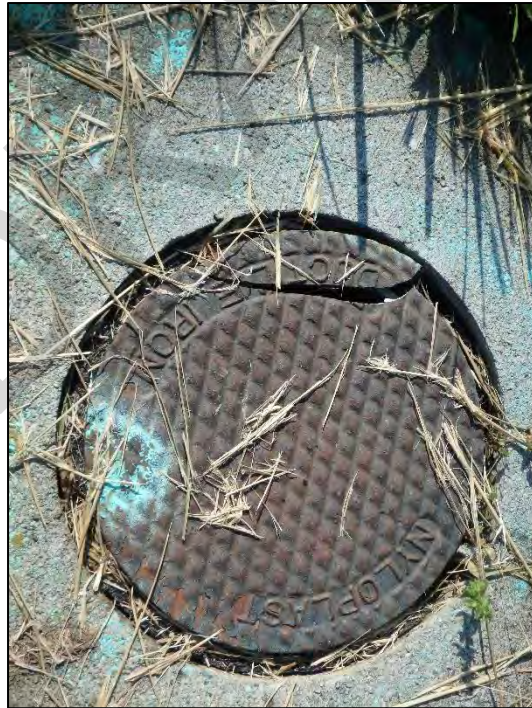
The outlet of the drain was found underneath heavy vegetative growth that had to be partially cleared. The cover on the toe drain cleanout near the middle of the dam is cracked. The seating of the toe drain cleanout cover directly upstream of the toe drain outlet has been damaged such that the cover no longer securely fits. It appears that both of these cleanouts were damaged by a mower.

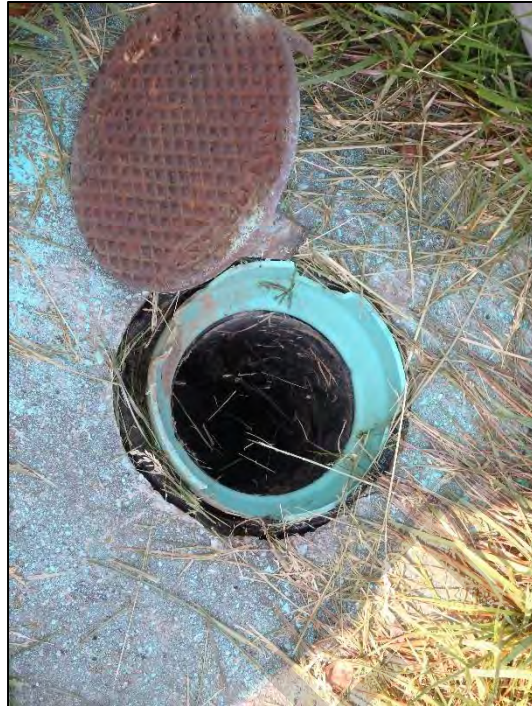
Top:	Downstream slope (directly upstream of toe drain outlet). Note damaged cleanout with cover not fitting securely.
Bottom:	Downstream slope toe drain outlet.

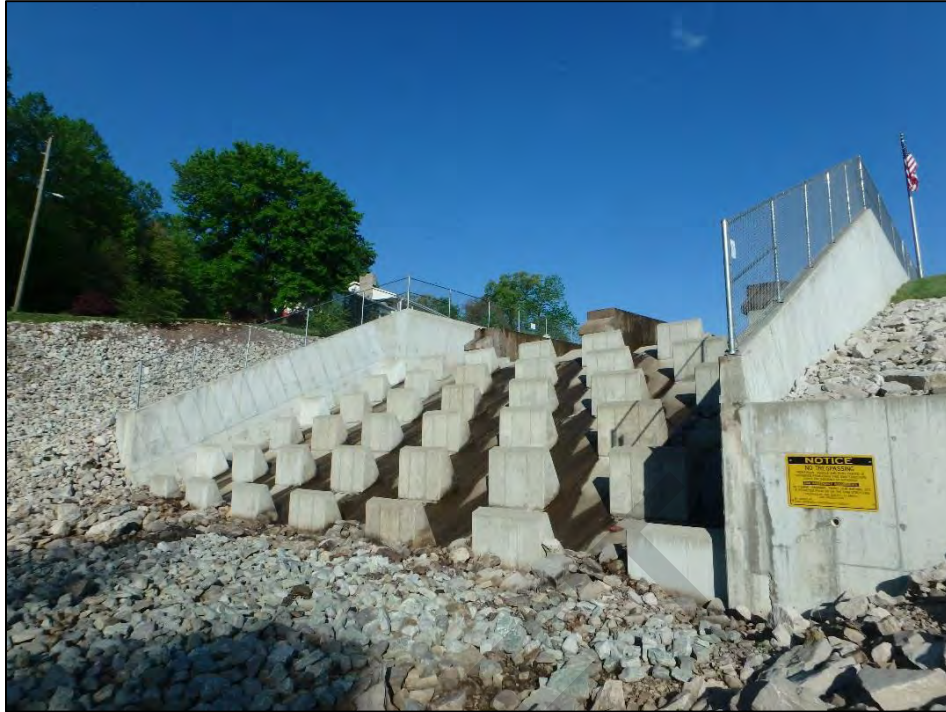
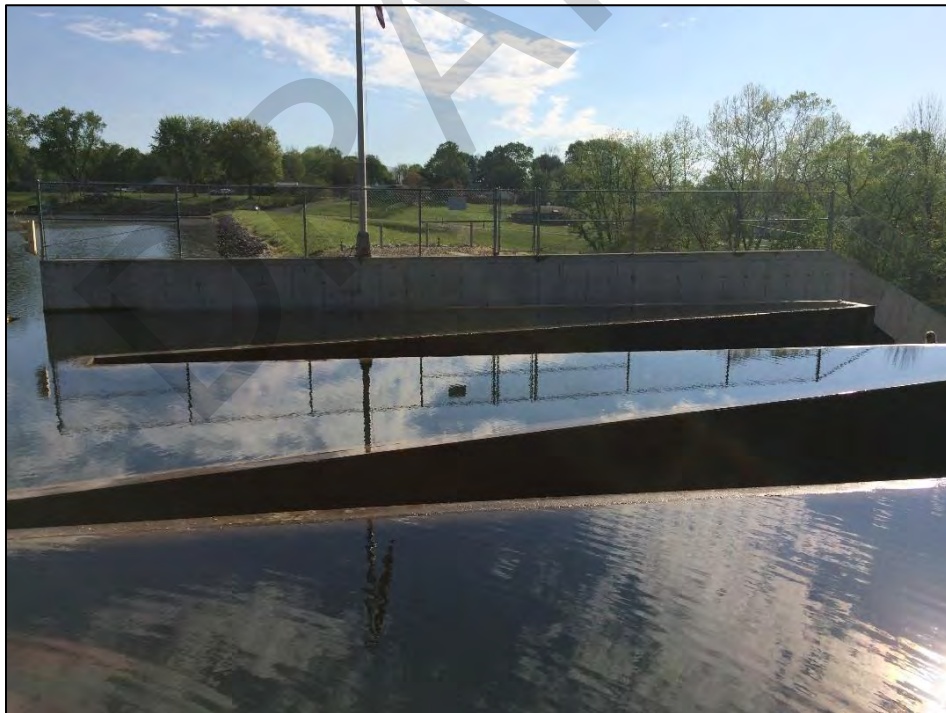
Top:	Principal spillway baffled chute. Note adequate riprap protection in downstream portion.
Bottom:	Principal spillway labyrinth weir. Note lake level at normal pool at time of inspection.

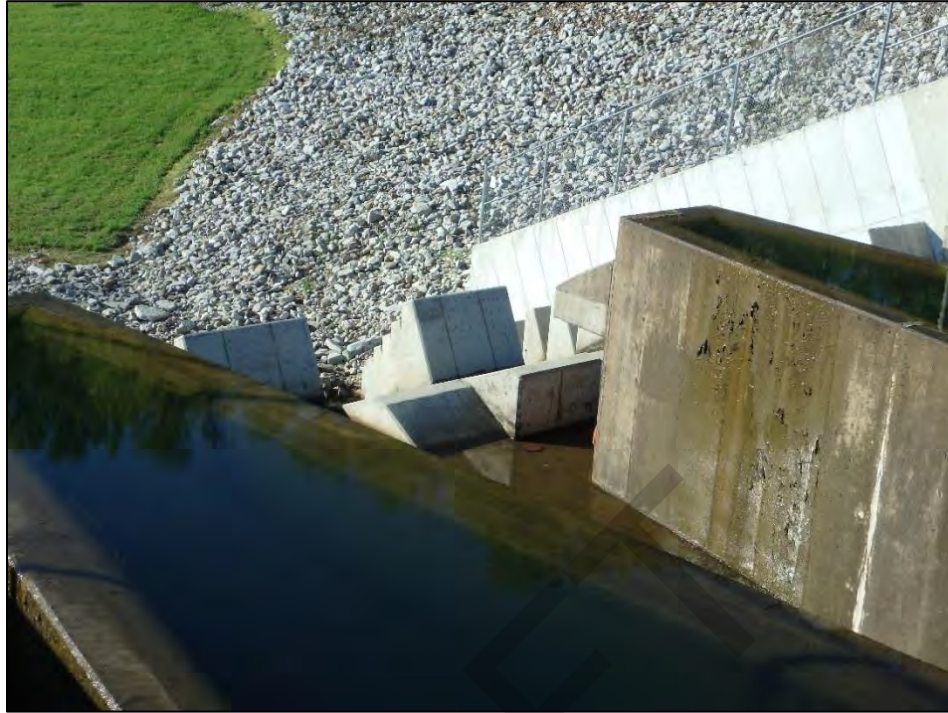
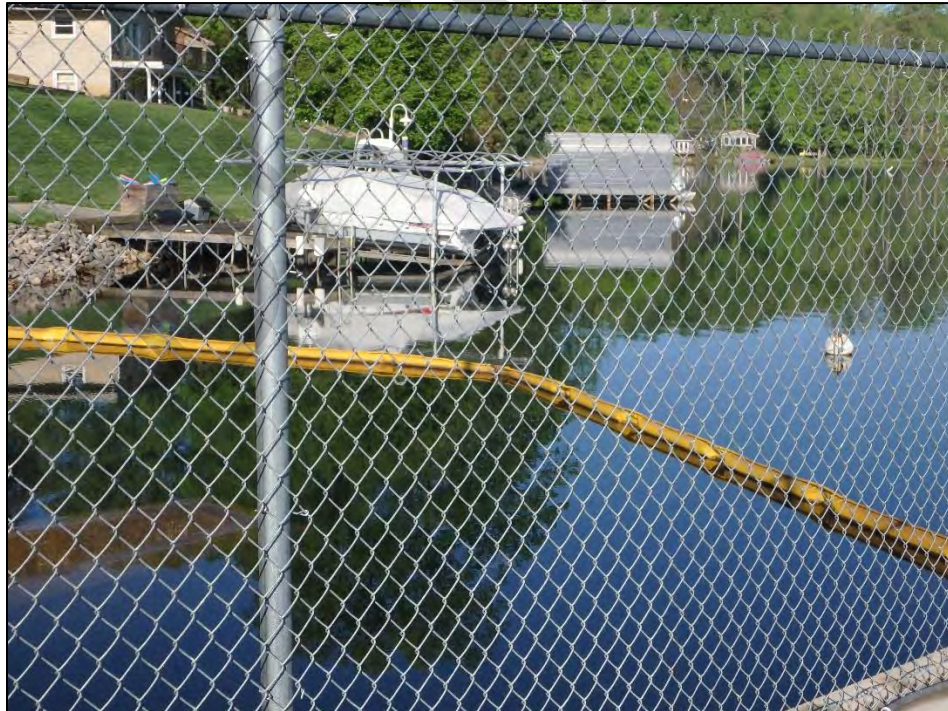
Top:	Principal spillway labyrinth weir. Note lake level at normal pool at time of inspection.
Bottom:	Debris boom immediately upstream of principal spillway.

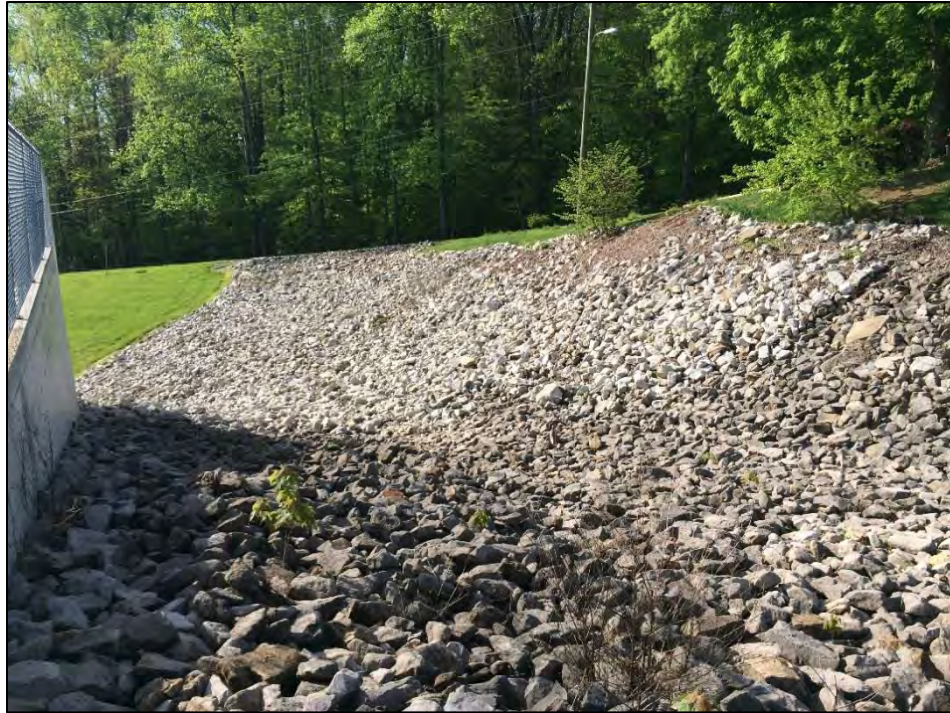
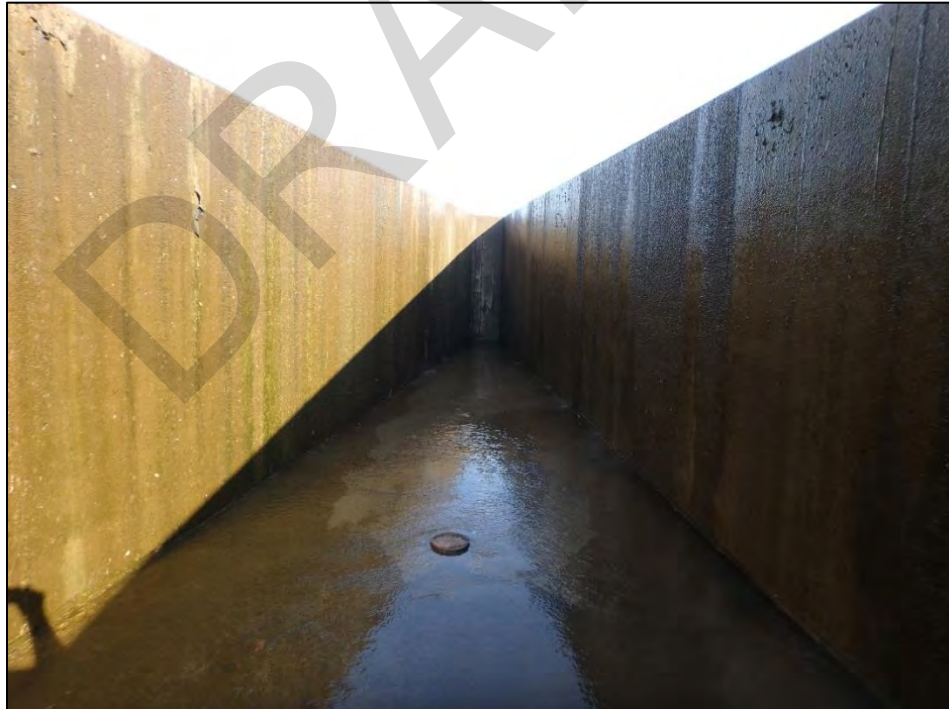
Top:	Principal spillway right abutment. Note area is armored with riprap.
Bottom:	Principal spillway labyrinth weir walls with pressure relief valve on slab.

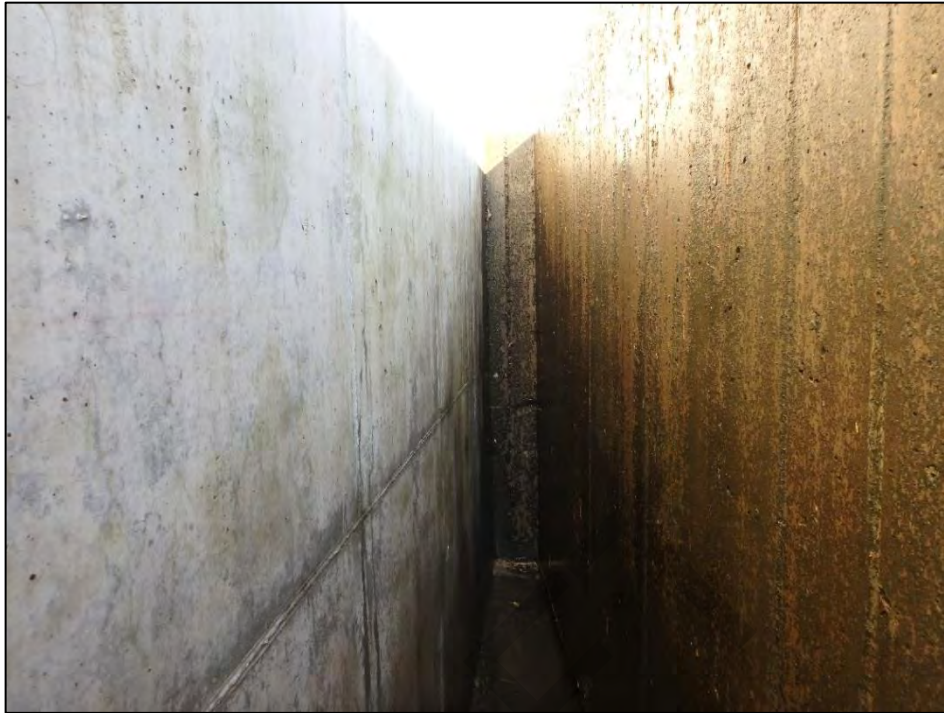
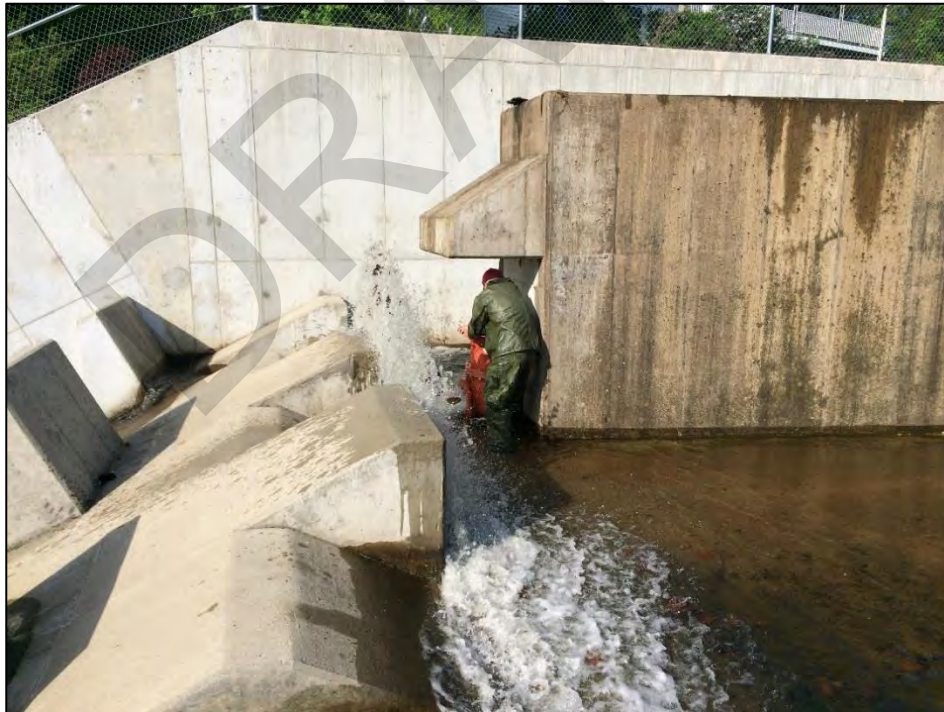
Top:	Principal spillway labyrinth weir walls. Note good condition of concrete.
Bottom:	Principal spillway right gate valve. Note operation of valve was performed at time of inspection.

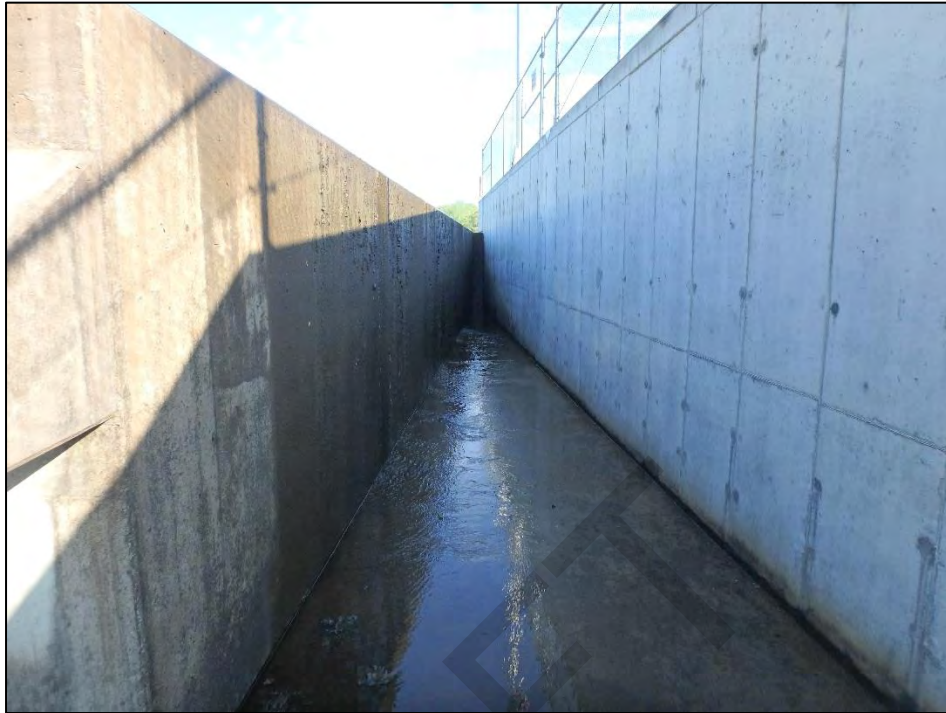
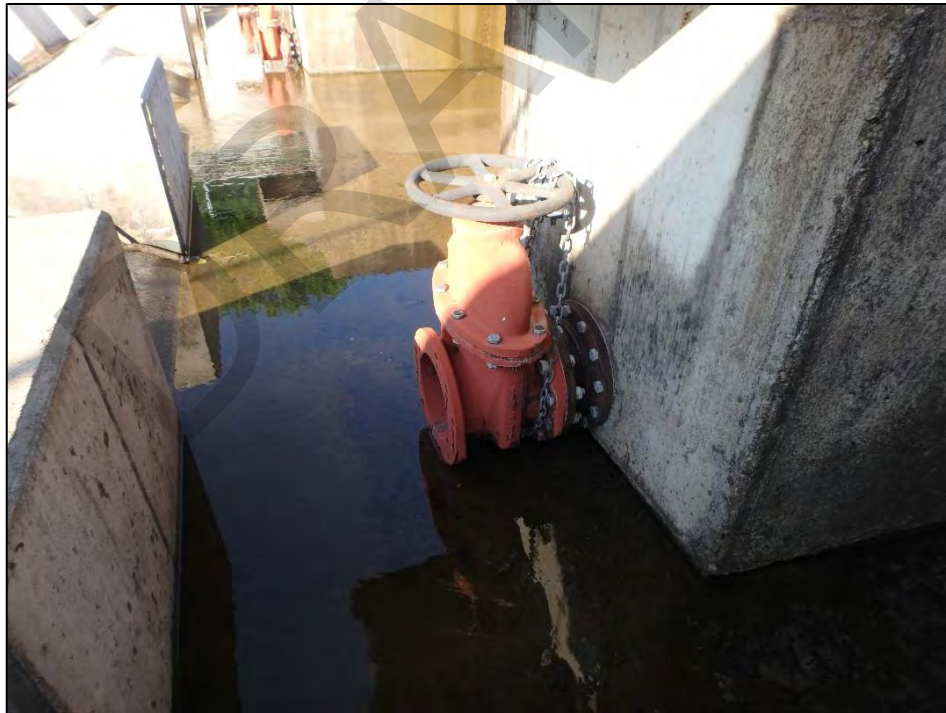
Top:	Principal spillway labyrinth weir wall and left spillway abutment wall. Note good condition of concrete.
Bottom:	Principal spillway left gate valve. Note operation of valve was performed at time of inspection.

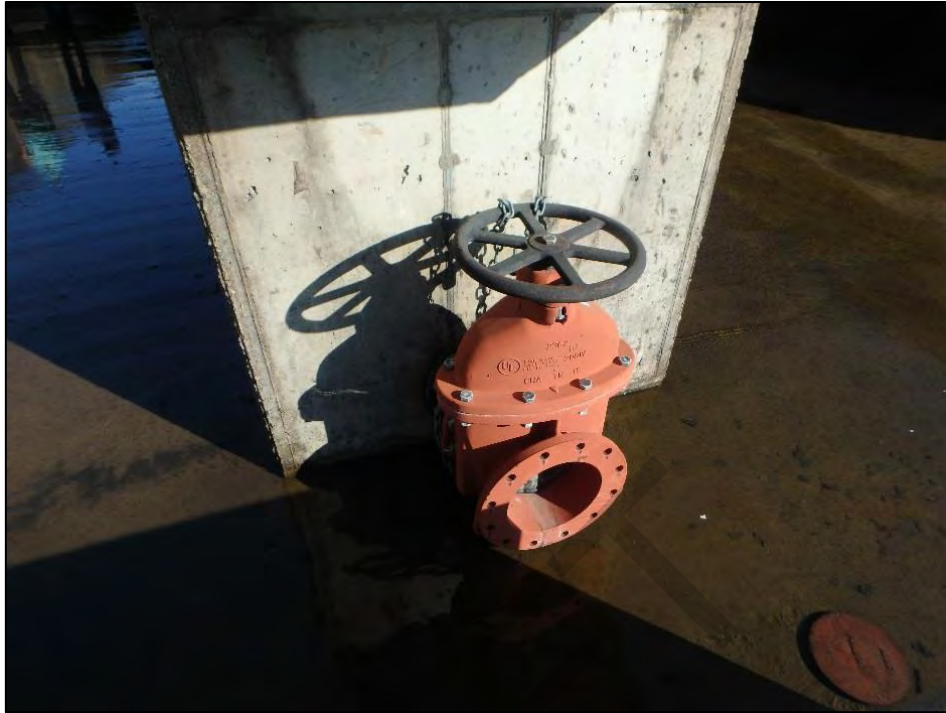
Principal spillway middle gate valve. Note operation of valve was performed at time of inspection.
--	--
